Inspection Report

**Property Address:
204 Movingup Ave
Hometown NJ 08835**

H&J Freile Home Inspection, Inc.

| Date: 8/3/2018 | Time: 09:30:00 AM | Report ID: Sample1 |

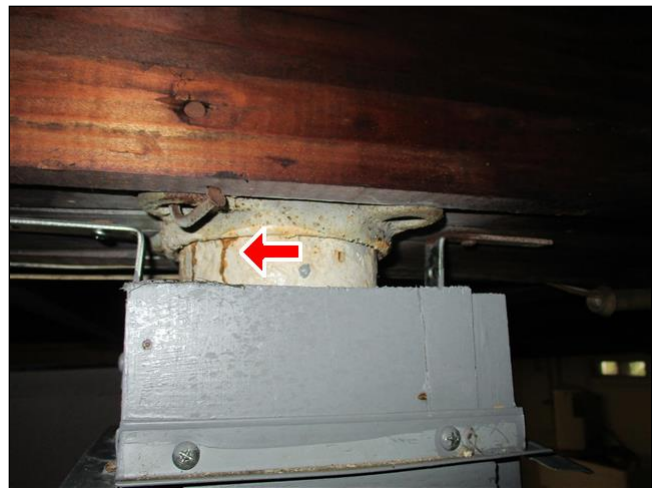
B. Item 1

Two of the lally columns are wrapped with wood and not visible. Evidence of rust stains were noted at the tops of the columns. It is recommended to remove the wood enclosures to allow full view of columns prior to closing.

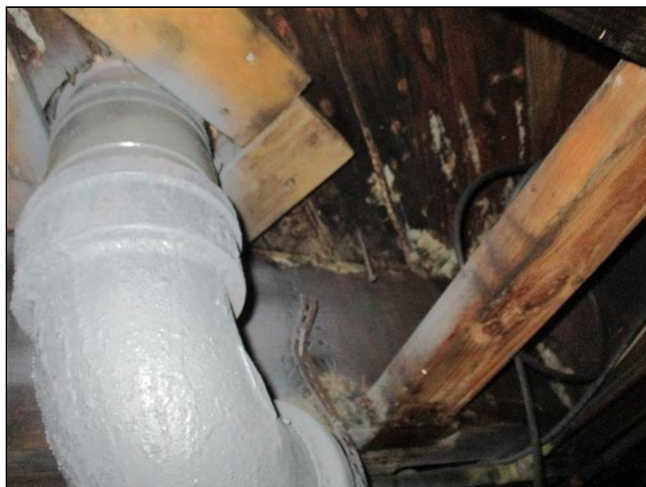
C. Item 1 Rotted sub-floor below toilet

(2) Damaged / rotted subflooring was noted below the toilet and some of the radiators. Repair / maintain as needed.

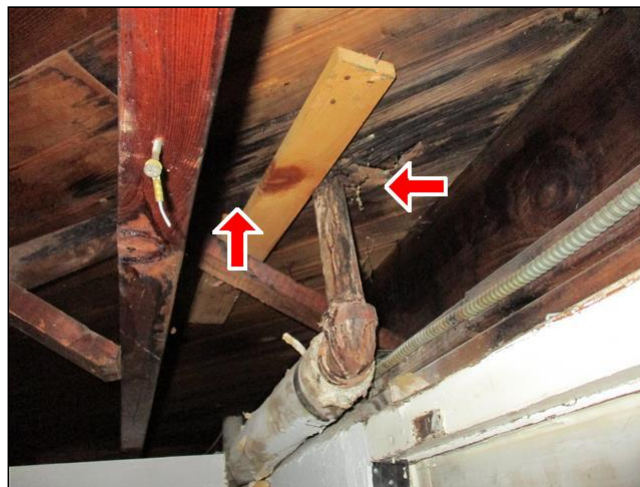
C. Item 2

(1) Termite damage was noted to the floor joist and front sill plate behind the front stoop. Replace damaged sill plate and joist as needed. Further evaluate for possible hidden damage during repair.

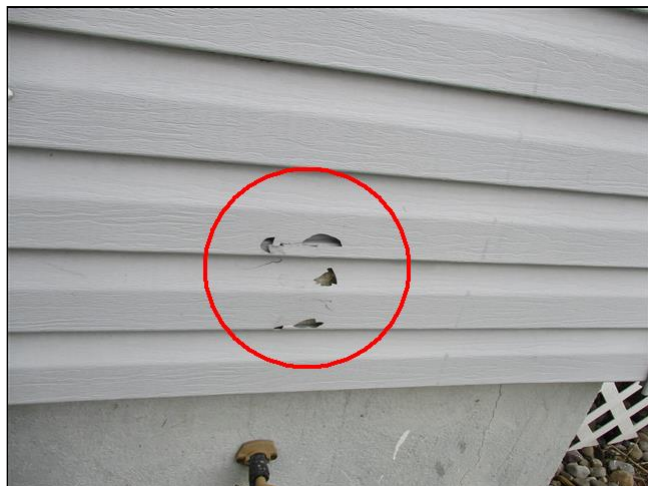
A. Item 1

(1) Some holes and cracked siding was noted. A missing area of siding was noted at rear bump out / Pantry area. The corner trim and this area is also cracked and damaged. Replace damaged trim and siding as needed to protect from weather intrusion and possible damage to the walls of the house.

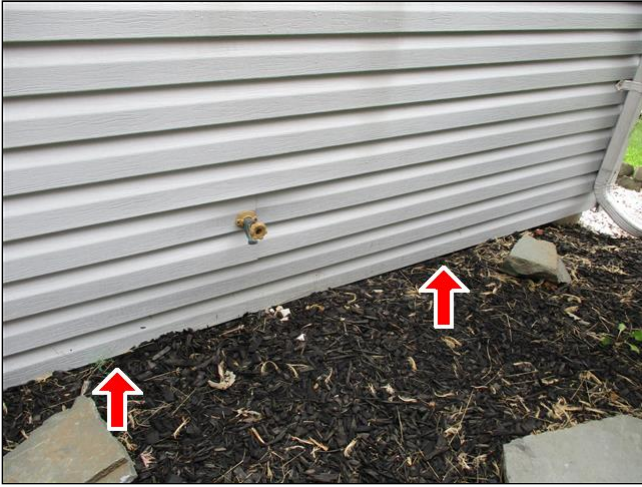
A. Item 4

(2) The grade is in contact with the siding at the front and side. Soil / siding contact is conducive to moisture damage and wood-destroying insect infestation. Lower grade as needed. Add drainage or improve grading to divert surface water away from the structure.

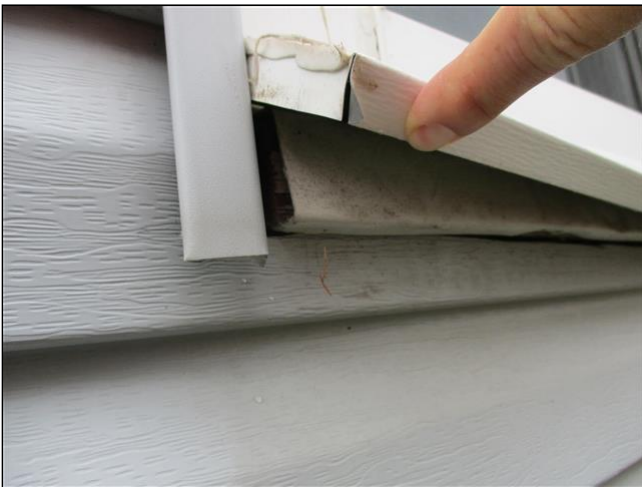
B. Item 1

(1) Loose and Improperly sealed trim wrap was noted at the windows. Poorly sealed or installed wrap can allow water to enter under the wrap which is conducive to decay of the underlying trim and structure. Seal open joints to protect from further water penetration.

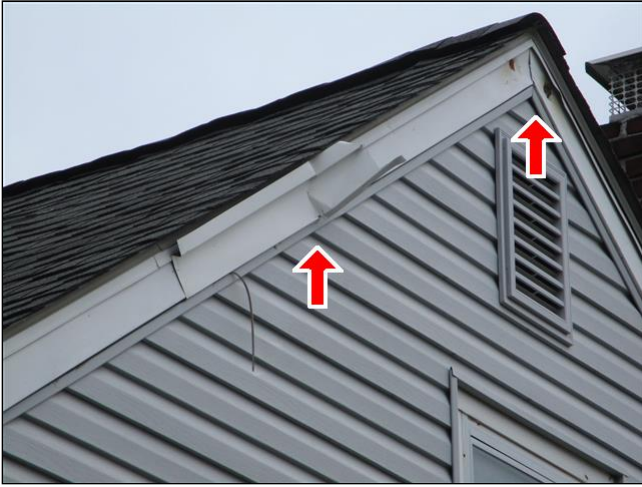
B. Item 2

(2) Damaged and loose aluminum trim was noted at the roof rakes. Replace damaged trim as needed to help protect structure from weather damage.

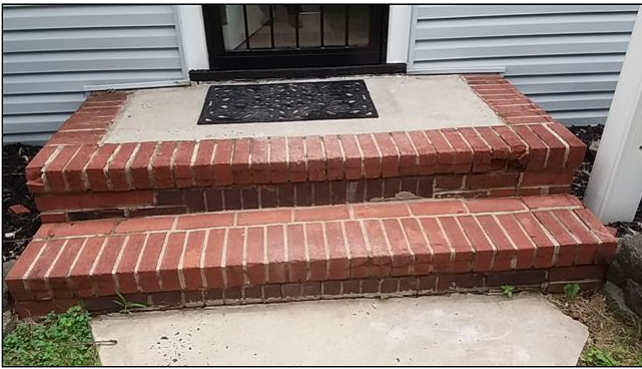
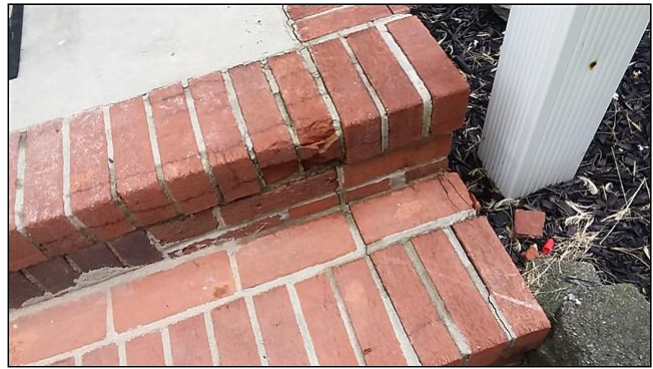
Loose, cracked and deteriorated brick was noted at the front step and stoop. Loose and damaged brick present at potential trip and fall hazard. Repair or rebuild the front stoop and steps to help protect from further damage.

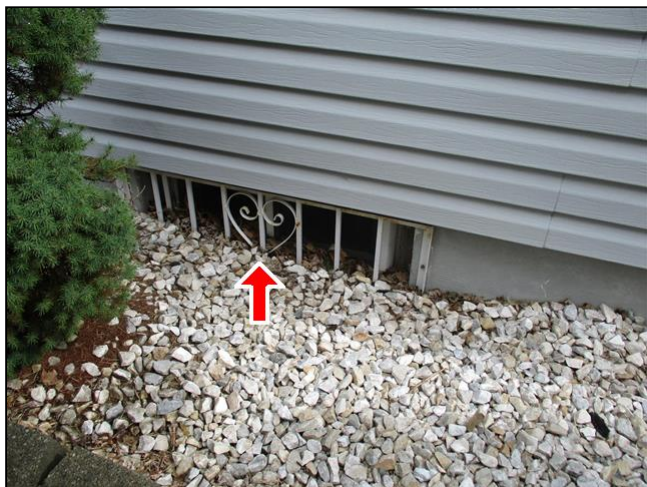
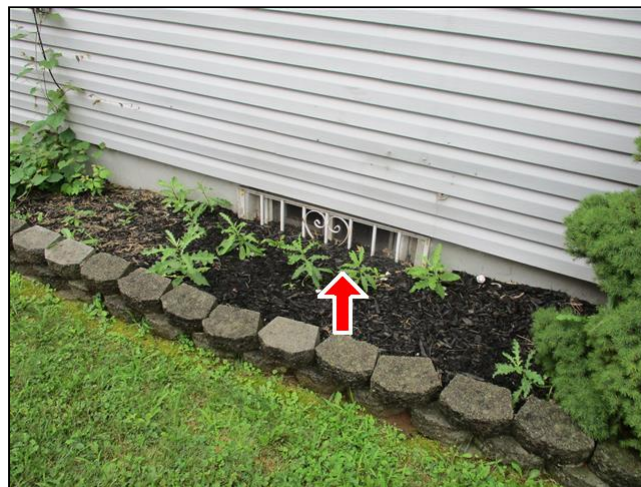
(1) The grade is above the bottoms of the basement window. Add window wells as required to help reduce water penetration under the windows and into the basement.

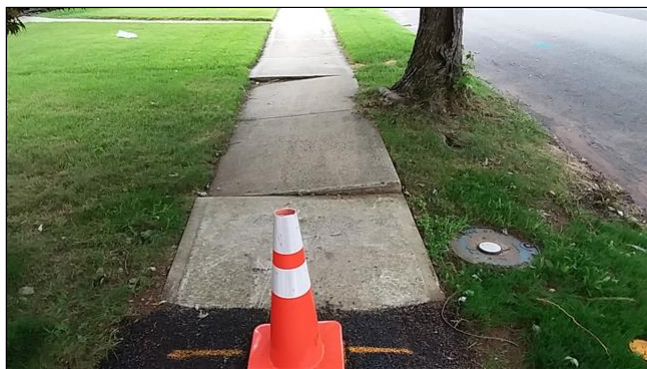
F. Item 1

The front public walk is heaved and uneven. An uneven walk presents a potential trip hazard. Repair as required for safety.

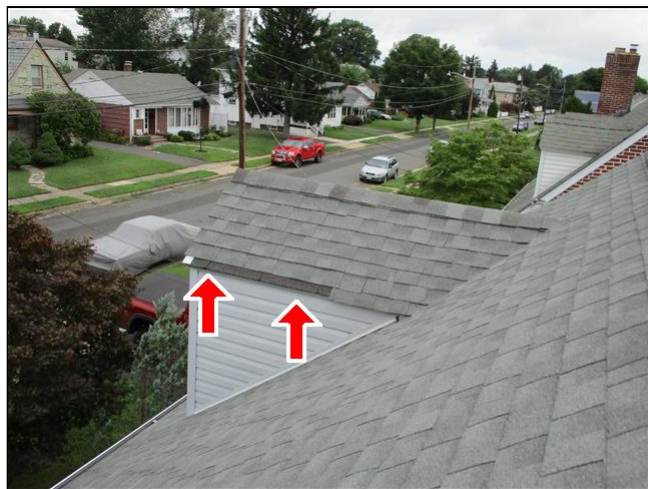
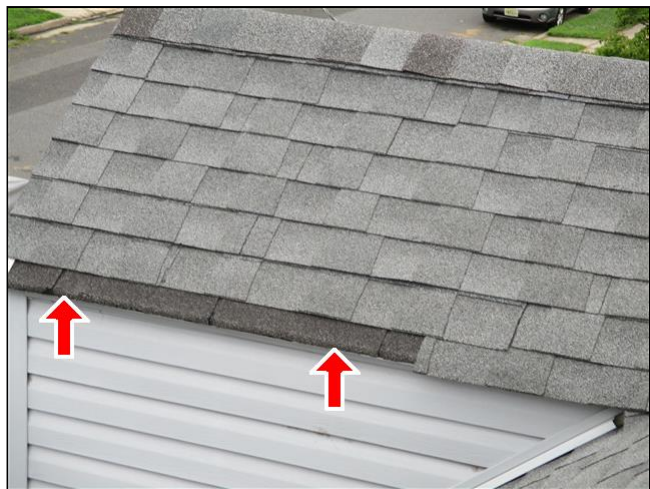
- Attention Required
- (1) The roofing is approximately 15+ years old. The typical life expectancy of a laminated asphalt strip shingle roof is 20-25 years.. The probability that the roofing will require replacement within 0 to 5 years is medium.
- (2) Two layers of roofing was noted. The maximum number of roof layers permitted is two. When it is time to replace the roofing, the existing roofing will need to be torn off which will require additional labor and disposal costs.
- (3) Missing shingles were noted at the left front dormer eave edge. Replace missing shingles as needed to protect from leakage.

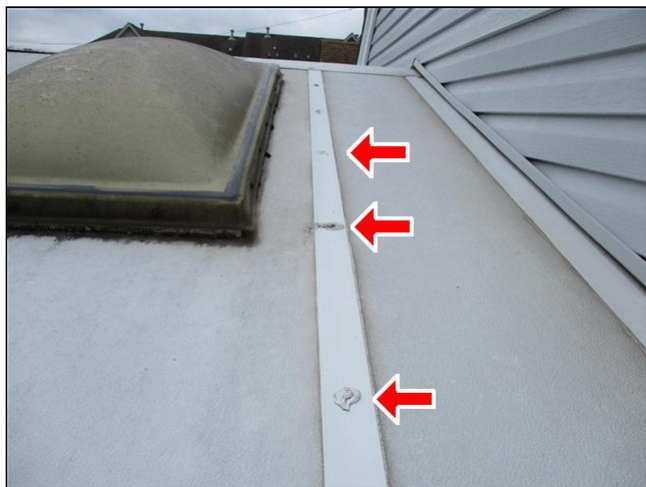
A. Item 3

- (4) Seal the exposed fastener heads at the enclosed porch roof to help protect against roof leaks.

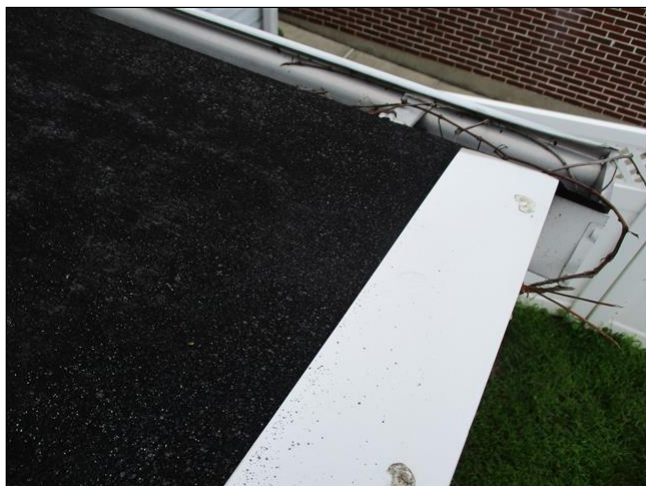
A. Item 4

(5) Flat roofs are more vulnerable to leaks than sloped roofs and often suffer from poor drainage. Flat roofs should have at least some slope to drain water because most roofing materials are not designed to resist standing water. Flat roofs typically have a higher degree of maintenance. Adequate drainage is critical on a flat roof to help protect from leaks and excessive weight on the support structure. Drains are prone to clogging due to falling leaves and tree debris. Routinely monitor the drains and as needed or at least seasonally. Some types of roofing material used for flat roofs will not serve as long as those for sloped roof areas.

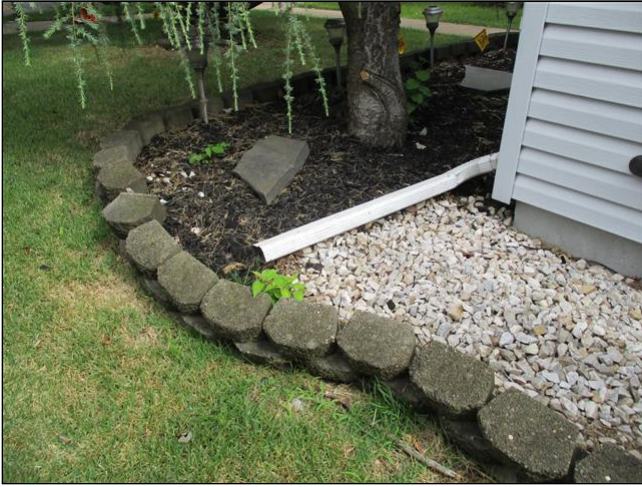
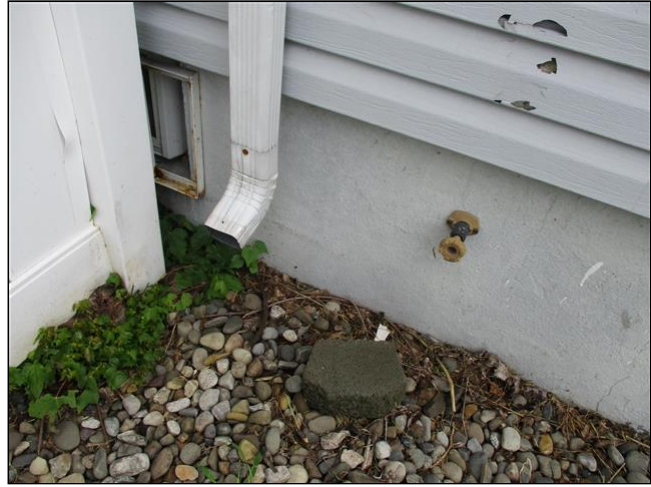
- (1) The gutters are clogged with debris. Clean out and maintain gutters to protect from possible water damage to the house and water entry into the basement or crawlspace.
- (2) Downspouts discharge near foundation. Extend away from house to reduce water penetration into basement.

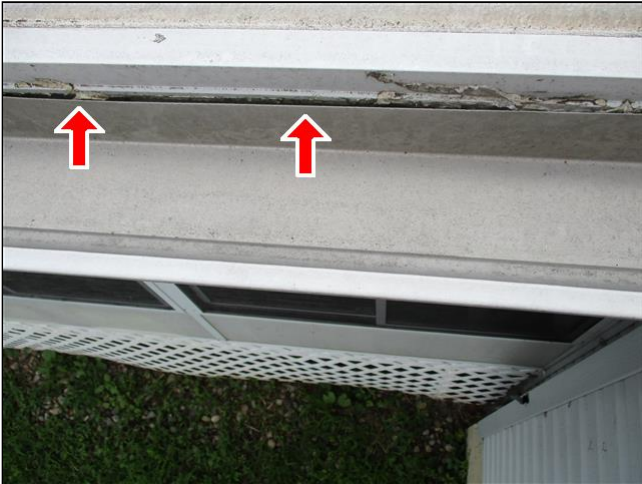
B. Item 3

(3) Water running off the enclosed porch roof can travel behind the gutter. Extend drip edge and / or seal joint between the back of the gutter and fascia to allow water to better travel into the gutter.

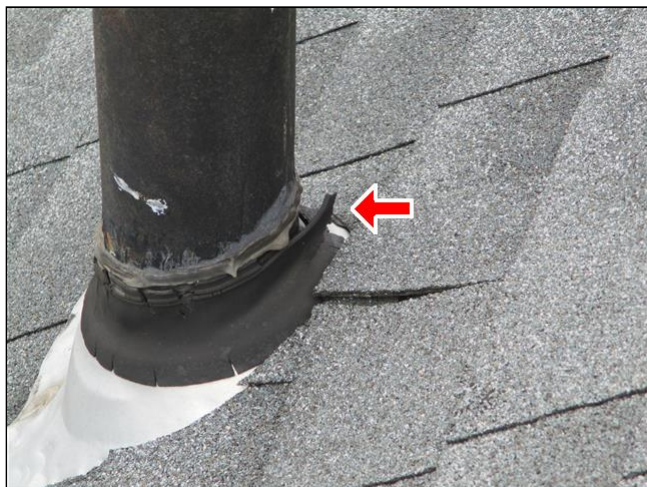
C. Item 1

The rubber flashing boot around the plumbing vent is cracked and deteriorated. Deteriorated flashing is vulnerable to leaks. The rubber flashing does not typically last as long as the roof. Replace deteriorated flashing boots as required.

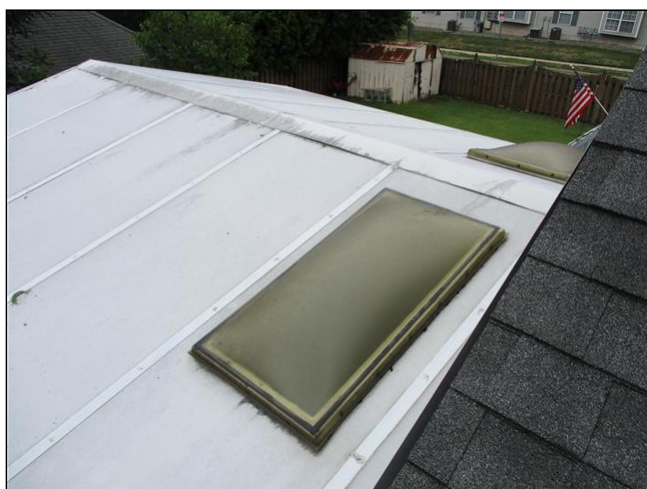
D. Item 1

The plastic dome on the skylights is scratched and clouded. A hole was noted on the inside layer of one of the skylights. The damaged skylight is more likely to leak and is less energy efficient. Replace domes or skylights as required.

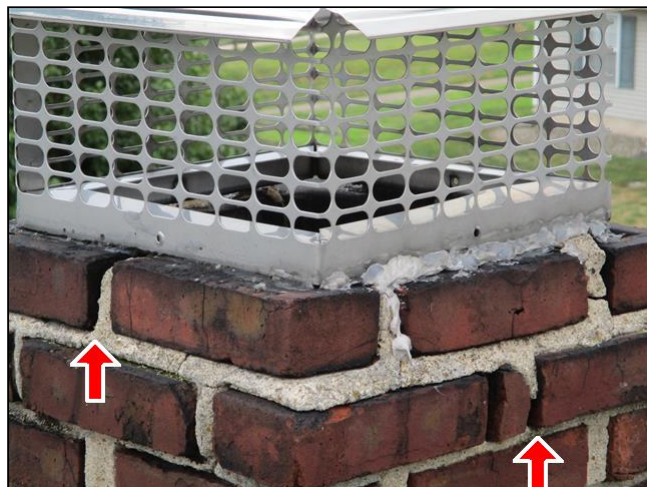
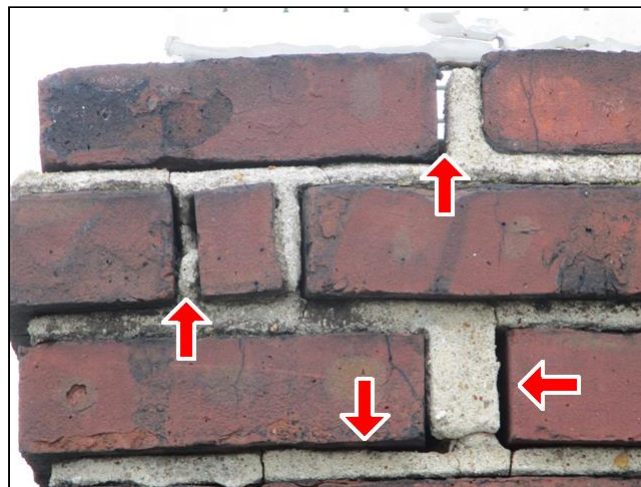
The top of the chimney is deteriorated. Deterioration noted includes, but may not be limited to, loose and cracked brick and missing mortar cap. Chimney deterioration can allow water penetration into the chimney structure and cause further damage and possibly blockage of the chimney or falling debris. Further evaluate chimney and flue liner by a qualified mason or certified chimney sweep prior to closing. Repair or rebuild chimney as required for life and fire safety.

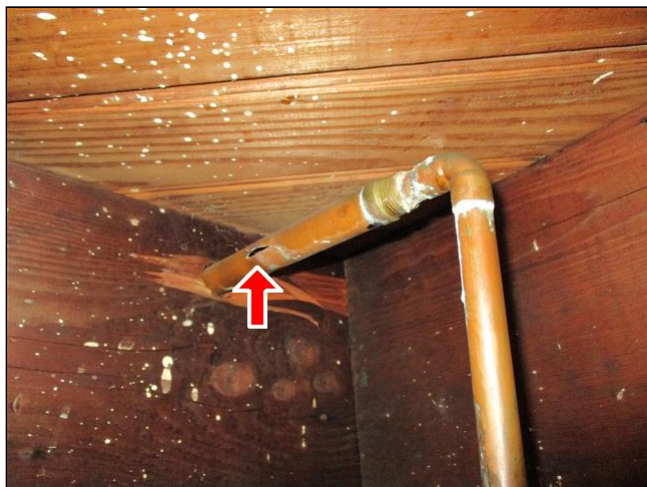
C. Item 1

(2) Pipes to the outside hosebibbs are vulnerable to freezing. The pipe to the front hosebibb is split and requires replacement. Frozen water pipes can burst and create extensive water damage. Take necessary precautions to protect pipes from freezing.

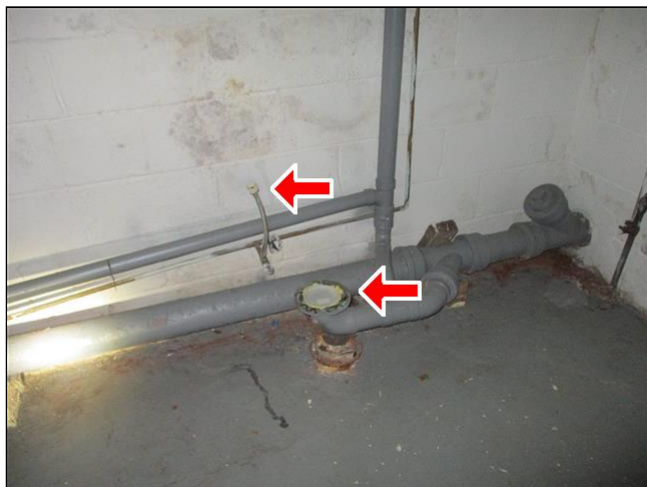
F. Item 1

(1) Properly cap and seal unused drain and water lines in the basement to help protect from possible leaks or back-up of sewage and gases.

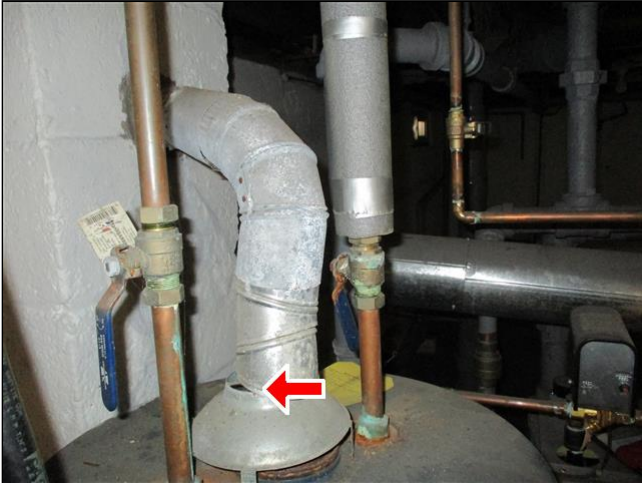
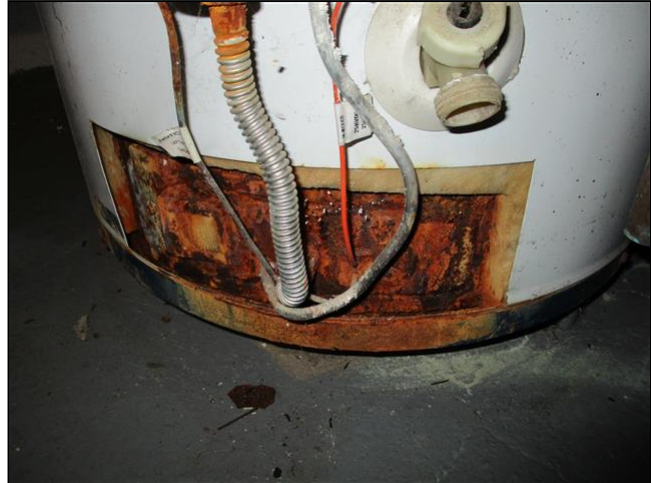
The water heater is unsafe to operate and at the end of its useful life expectancy. Replace the water heater as required for function and safety.

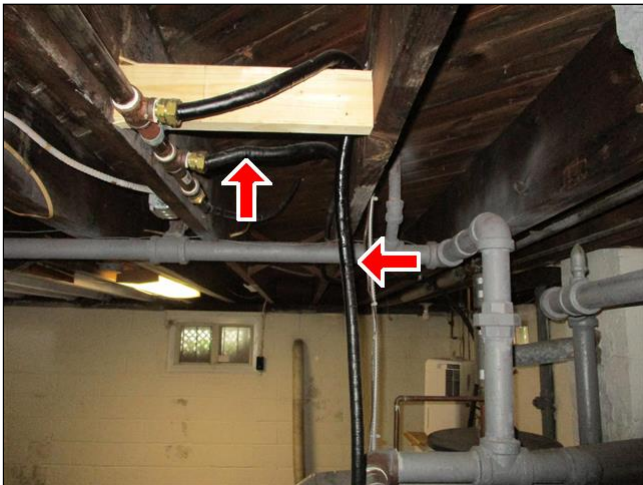
I. Item 1

(2) Corrugated Stainless Steel Tubing (CSST) is used to pipe gas to the boiler, water heater and stove. CSST should be bonded to ground to dissipate electrical current to help protect the tubing from potential damage due to electrical arcs and/or lightning although the manufacturer's requirements for different types of CSST may vary. In addition, adequate spacing should be maintained between the CSST and other metal components (such as copper pipes) to protect from potential arcing. No visible bond was noted between the gas piping and electrical ground. Install proper ground bonding for safety. Obtain the manufacturer's installation requirements. Obtain all necessary permits and approvals for the gas pipe installation.

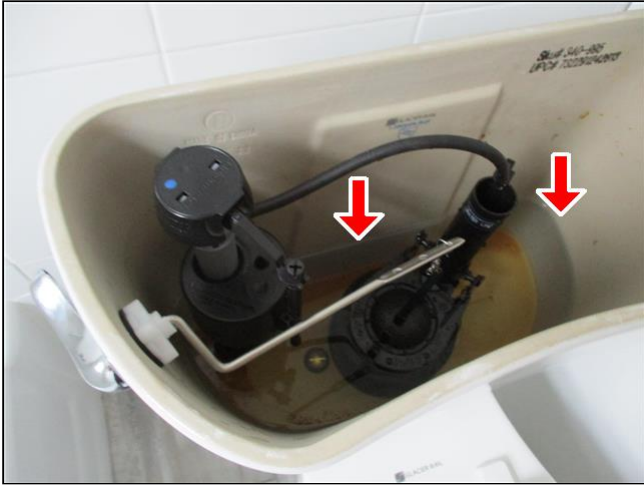
J. Item 1

The toilet tank did not properly re-fill to allow the toilet to be flushed (after initial flush). Further evaluate and repair as required.

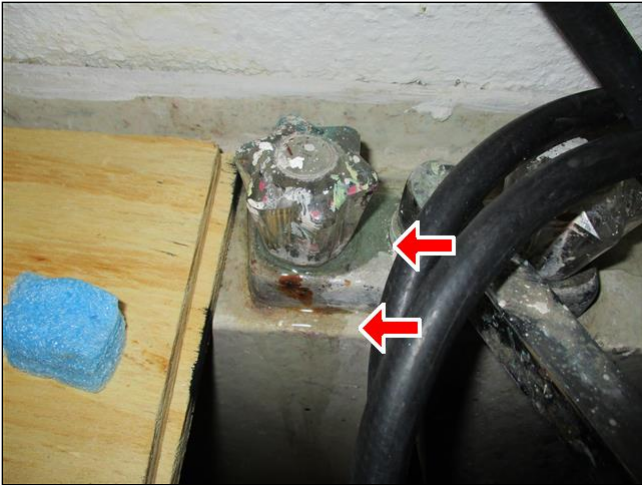
K. Item 1

(1) Repair / replace the leaking faucet at the basement laundry tub.

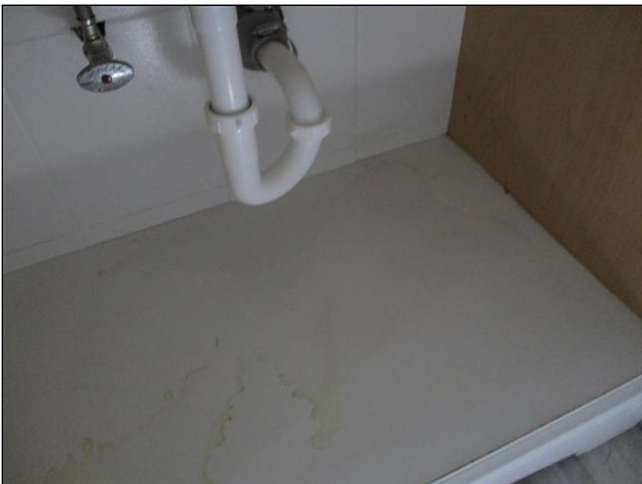
K. Item 2

(2) The bathroom sink drain leaks. Repair as required to help protect against water damage to the cabinet and finishes below. Chronic water leaks are conducive to mold growth.

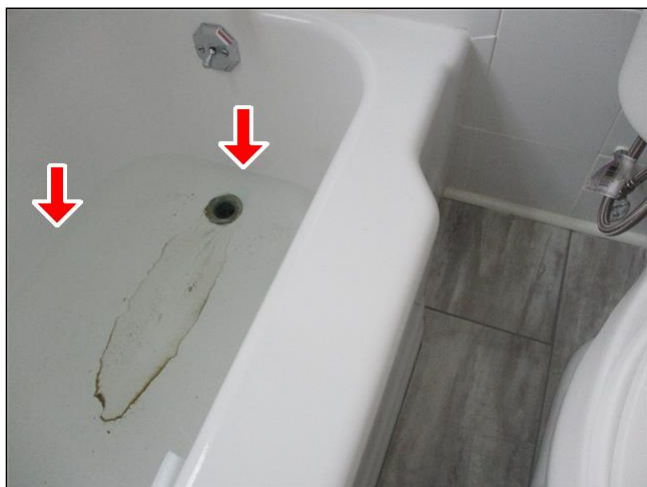
L. Item 1

(1) The bathtub drain is stopped. Clear drain and re-evaluate prior to closing to verify drains are working properly.

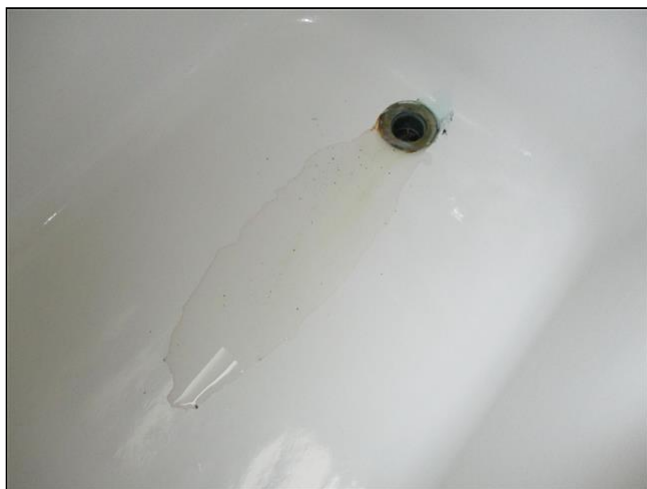
L. Item 2

(3) A stain and water puddle was noted in the bathtub which appears to be due to a dripping faucet. The tub and tile enclosure have been painted over. Repair dripping valve as needed. Clean and maintain tub as needed. Do not use abrasive cleansers on the tub.

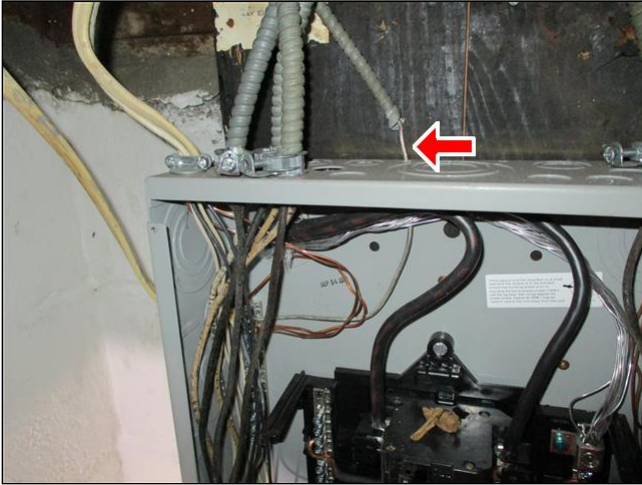
D. Item 1

| The system appears to be grounded to the metal water pipe only. When the electric is upgraded or if the main water line is replaced, additional grounding (typically by installing ground rods) will be required. | |

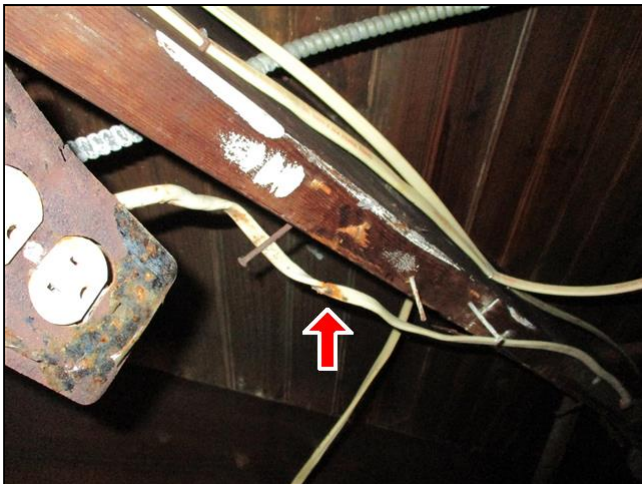
G. Item 1

(2) One of the loose / hanging wires appears to have the insulation nicked and possibly shorted. Further evaluate and repair as required.

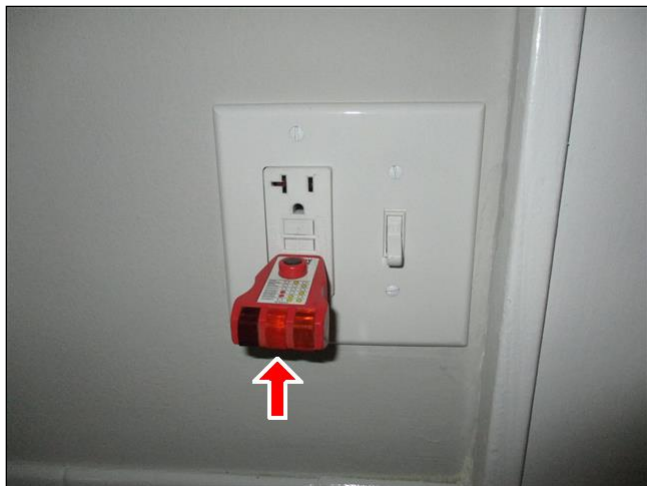
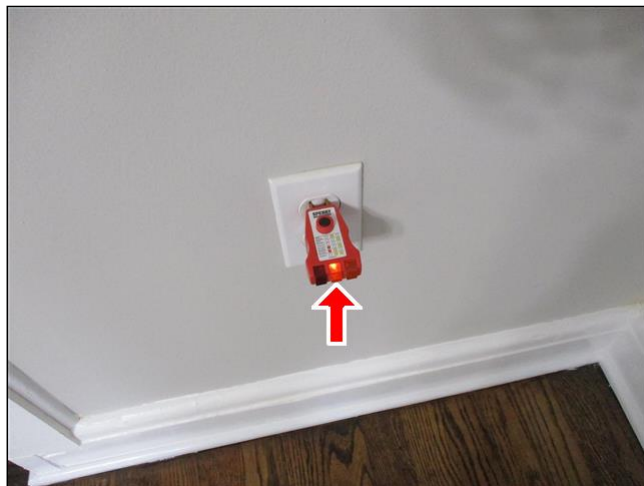
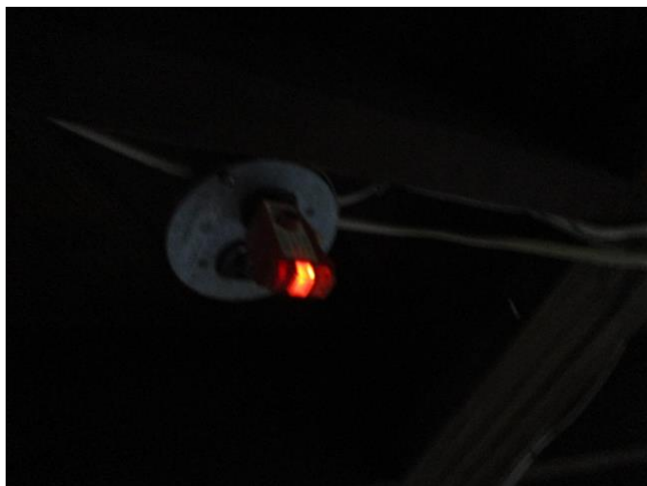
(1) Improperly wired open ground receptacle(s) were noted at the front wall of the first floor, basement ceiling and in the bathroom. Improperly wired receptacles present a potential shock hazard and can damage electrical appliances. Repair as required for safety. Since only a representative sample of receptacles were tested in each room, it is recommended that all of the receptacles be tested during the repair.

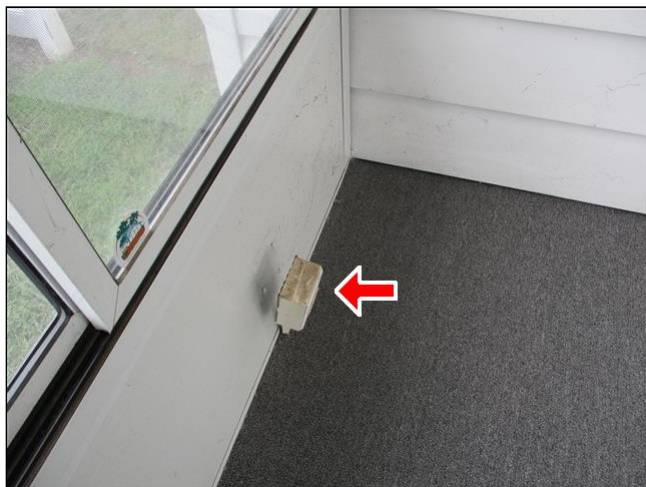
H. Item 4

(3) One of the receptacle boxes in the enclosed porch is pulled off the wall. Secure the box and receptacle as needed for safety.

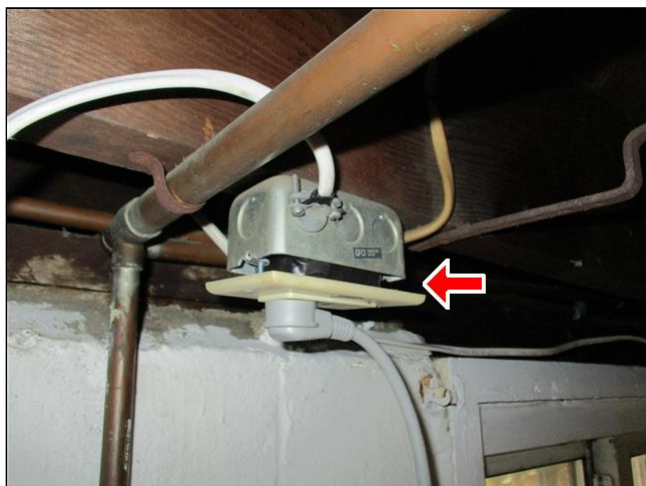
H. Item 5

(4) The receptacle box at the basement ceiling (for a GFCI receptacle) is undersized. Replace with a properly sized electrical box and secure loose wires as required for fire and personal safety.

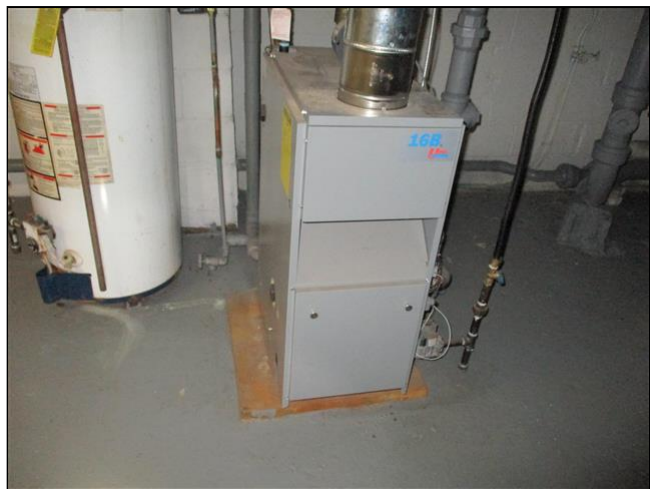
B. Item 1

(1) The steam boiler appears to be new. The typical life expectancy of a boiler is 15-20 years. The probability that the boiler will require replacement within 0 to 5 years is low.

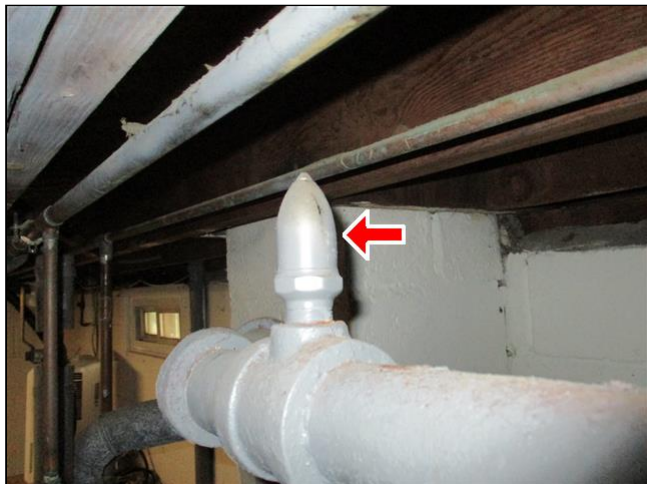
E. Item 1

- (1) No heat source was noted in the kitchen. It appears a radiator has been removed. Further evaluate by a qualified mechanical contractor. Add appropriate heat source in the kitchen for comfort.
- (2) There is no heat source in the enclosed porch.
- (3) The old steam vent(s) are painted and suspect. The vents should be replaced for improved heat distribution and energy efficiency.

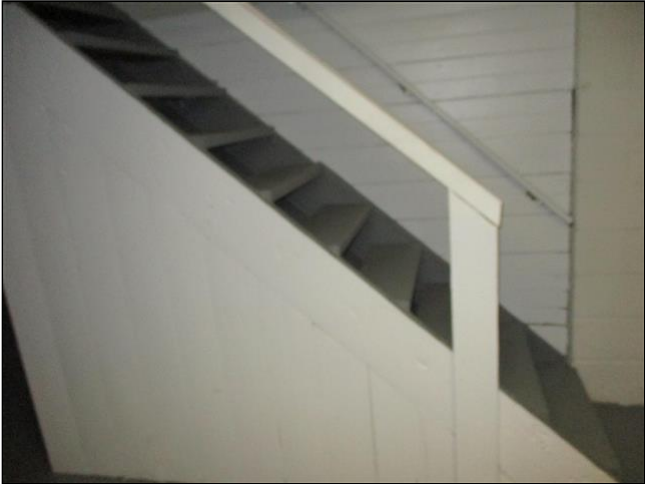
D. Item 1

- A. Walls
Functional
- B. Ceilings
Functional
- C. Floors
Functional
- D. Steps, stairways, railing
Attention Required
An open stairwell was noted to basement. An open stairwell increases the risk of injury in the event of a slip or fall. Add / enclose railings for safety.

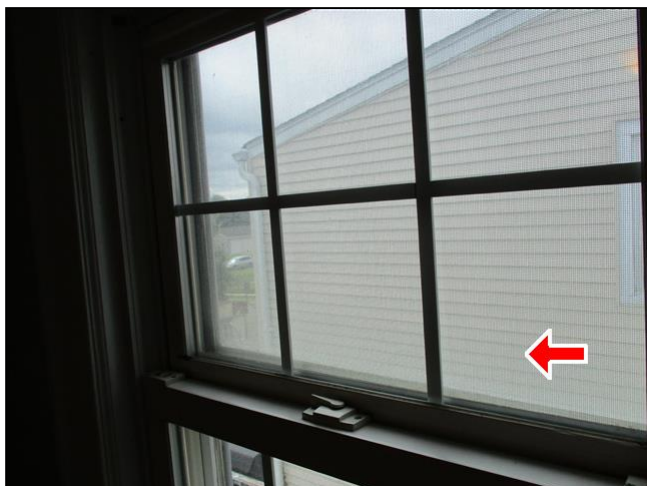
E. Item 1

becomes obvious and unsightly. The seal cannot be repaired. Replace the insulated glass panels and/or windows as needed to restore clear visibility.

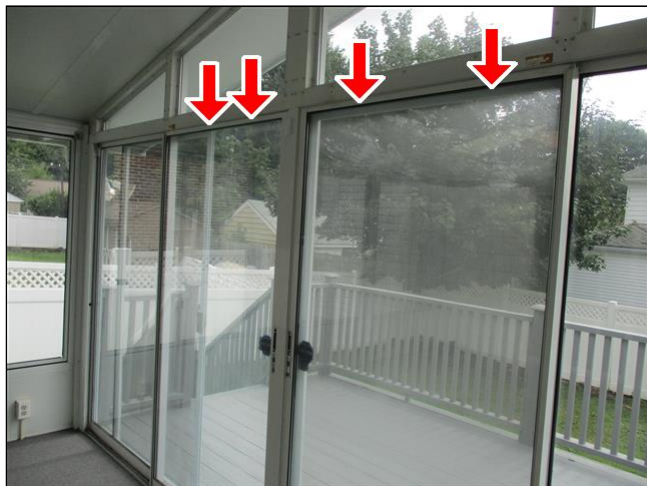
F. Item 1 Clouded glass

(1) The sliding doors in the enclosed porch (3) have lost their seal between the insulated pane(s). When the seal is lost, condensation will form between the glass panels. Cloudiness builds up until it becomes obvious and unsightly. The seal cannot be repaired. Replace the insulated glass panels and/or doors as needed to restore clear visibility.

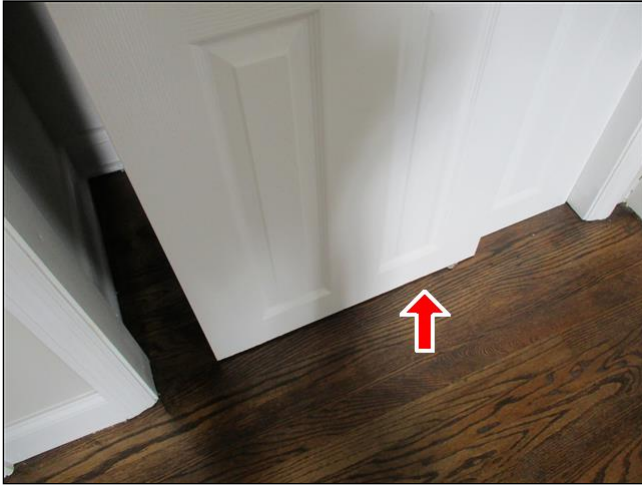
F. Item 2

(3) Floor guides are missing for the closet doors.

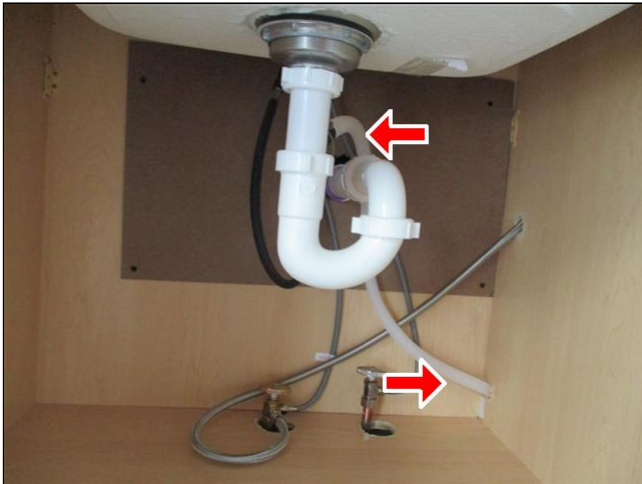
I. Item 1

(1) No 'high-loop' configuration was noted on the dishwasher drain pipe to prevent water from the sink drain backing into the dishwasher drain or remaining in the hose. Further evaluate and add loop as needed. See dishwasher installation manual for additional information.

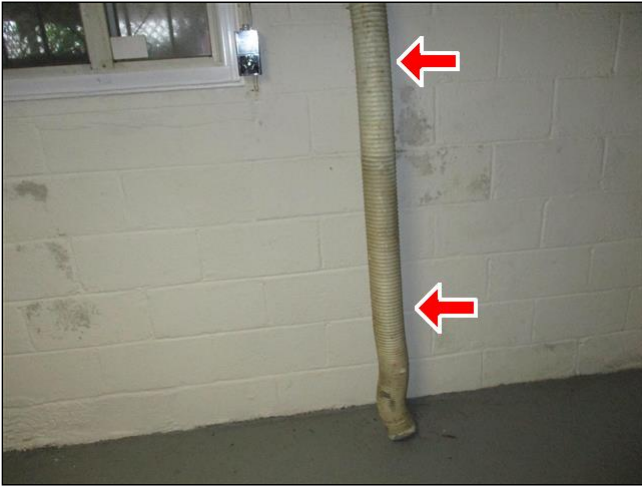
K. Item 1 Unsafe plastic dryer vent

(2) Flexible plastic duct is improperly used to vent the dryer exhaust to the exterior which creates a potential fire hazard. Only smooth wall metal pipe should be used for the dryer exhaust. A flexible metal connector is permitted to connect the dryer to the exhaust duct. Repair as required for fire safety and improved efficiency.

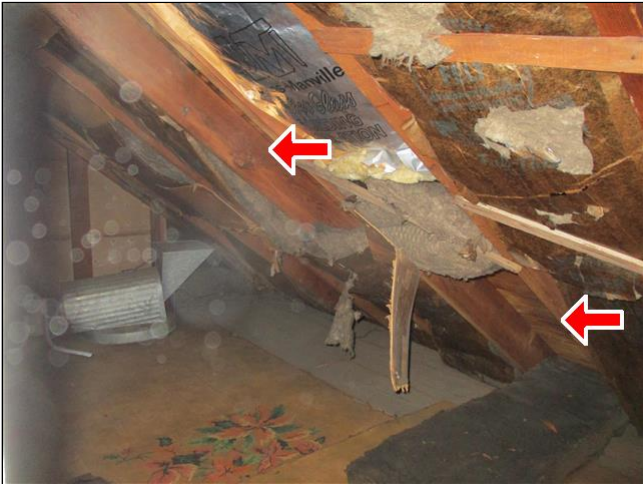
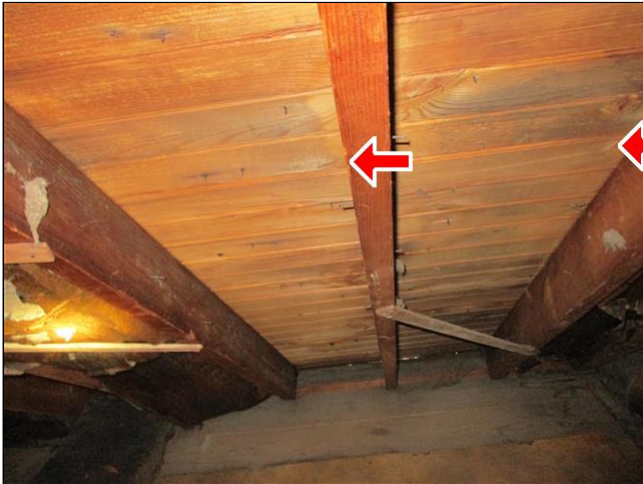
(2) Misplaced / missing insulation was noted in the attic. Reset / replace misplaced and missing insulation as needed for improved energy efficiency and to reduce potential for condensation in the attic.

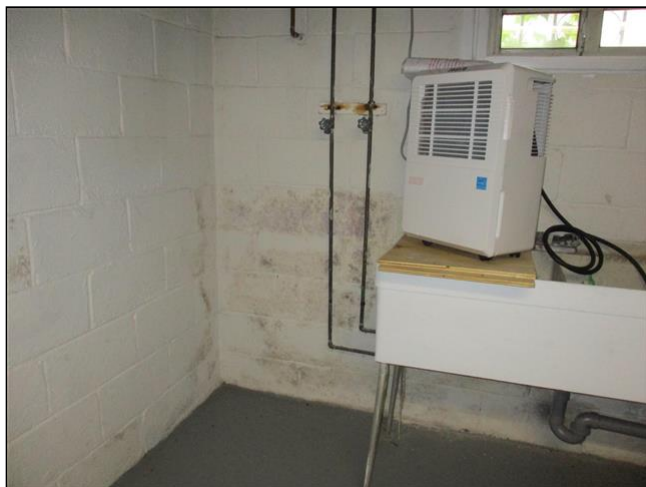
H. Item 1

Efflorescence, peeling paint, stains rotted / decayed wood and probable mold are symptoms that likely indicate persistent and/or chronic moisture and/or water penetration in the basement. Efflorescence is a white fuzzy or powdery mineral deposit left behind when moisture moves through concrete or masonry. Wood will rot and decay when in contact with water over a period of time and on multiple occasions. Wet wood provides an environment conducive to fungus and mold. Obtain additional information from the current homeowner regarding history of water or moisture penetration. A majority of moisture or water penetration in basements and crawls is due to improper grading and drainage and lack of proper maintenance. Take necessary measures to correct causes of water penetration and repair any related damage.

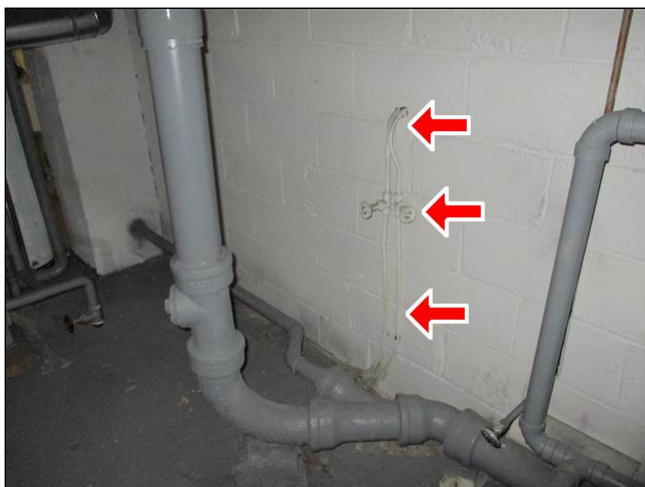
M. Item 1 Abandoned oil lines

underground tank prior to closing. An abandoned underground tank, if present, can present a potential environmental hazard. All underground metal tanks will corrode and eventually leak if not properly cleaned and abandoned. Removal of any underground oil tank is recommended to help avoid potential future and expensive environmental issues.

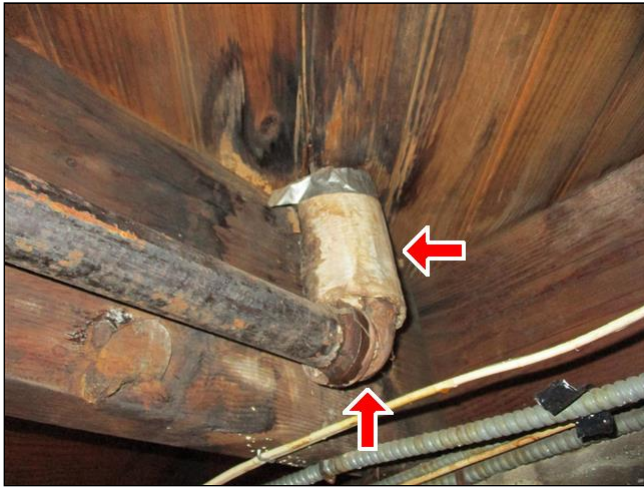
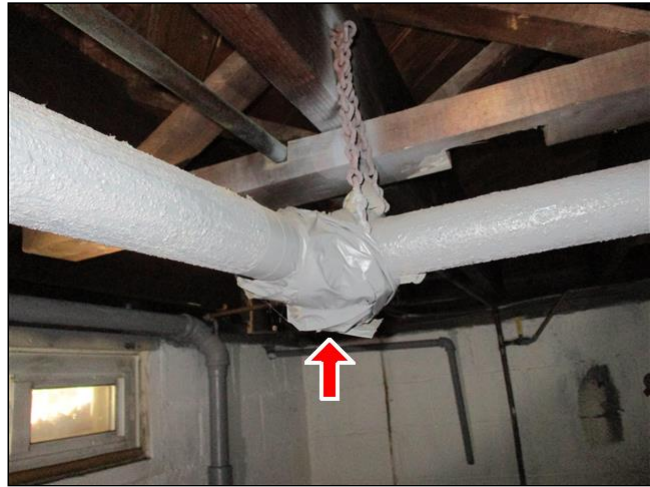
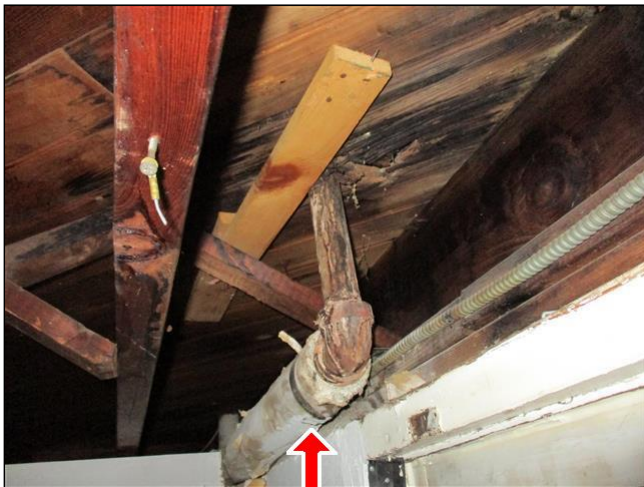
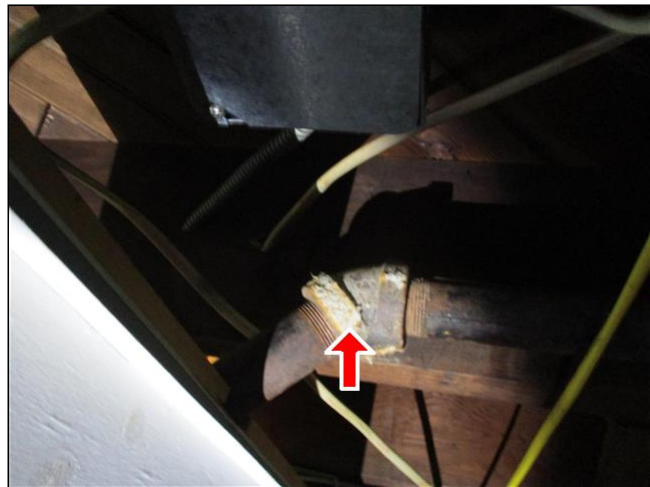
(3) Insulation was noted on several sections and fittings on the steam pipes in the basement. This material is friable and may contain asbestos. Old sheet vinyl flooring was noted in the eave attics. The backing of sheet vinyl may contain asbestos which can become friable if disturbed. Further evaluate by a licensed asbestos contractor prior to removing or disturbing this material. Removal by a qualified contractor is recommended. Testing or identifying asbestos or any hazardous material is beyond the scope of a home inspection. If you would like to have material tested for asbestos, please contact our office for pricing and scheduling. Professional removal of the pipe insulation and sheet vinyl is recommended. For additional information regarding asbestos in the home, the following websites are recommended. <http://nj.gov/health/ceohs/asbestos/asbestos-faq/> and <http://www.nj.gov/dep/dshw/rrtp/asbestos.htm>

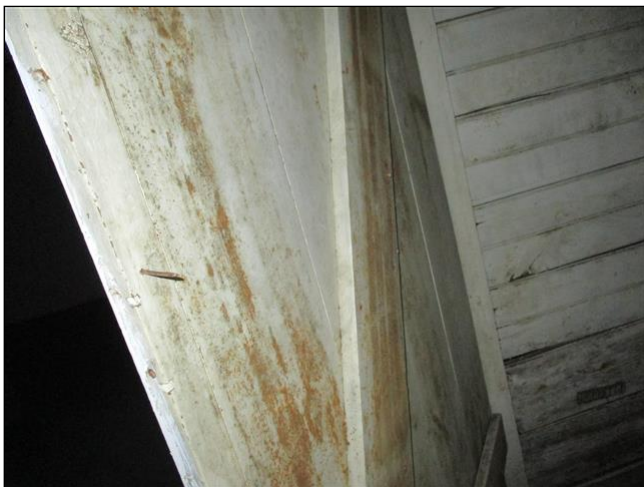
M. Item 6 Suspect mold below basement stairs

(4) A black and gray mold-like substance was noted at the basement closet below the stairs. Correct moisture and humidity problems in the basement. Add ventilation in the closet. Install a dehumidifier in the basement. Further evaluate by a qualified mold specialist. Clean up possible mold as required.
